M&C Zambia completes compressor motor overhaul in rapid time

In August 2022, Marthinusen & Coutts Zambia was tasked with a challenging assignment. A smelter based in the Copperbelt region requested an in-country repair solution for their two critical 4.5MW compressor motors. The company was given a tight deadline of just three weeks to overhaul and commission the motors.

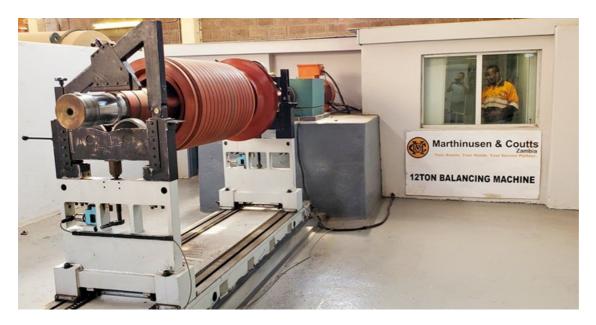
"Upon dismantling both motors we identified that the stator coils indicated partial discharge and the stator wedges had deteriorated significantly over time. We consequently requested M&C's workshop in Cleveland, Johannesburg to supply partial discharge treatment of the stator coils and to manufacture the stator wedges that needed to be replaced," said Eugene Lottering, M&C Zambia's GM.

The comprehensive scope of work involved dismantling, cleaning, and assessing all parts of the motors. The team at then dynamically balanced the rotors at operating speed using their own 12-tonne balancing machine.

Following this, they supplied new bearing assembly parts and assembled the motors. The final steps included a no-load test and laser alignment of the motors on site. This rapid and efficient response showcases the company's commitment to providing high-quality, timely solutions to its clients.

"Our team is well experienced in how to approach and action various stages throughout the overhaul of these motors. We successfully completed various medium voltage overhauls up to 4,650kW. The motors were no-load tested at 11kV with exceptionally good results and the customer then gave us the go-ahead to commission the motors," Eugene explained.

The motors were finally tested on load, recording satisfactory vibration levels of below 1.34mm/s.
